# AIRCRAFT ACCIDENT REPORT

UNITED AIR LINES, INC.

Boeing 737, N9031U

REPORT NUMBER: NTSB-AAR-73-16

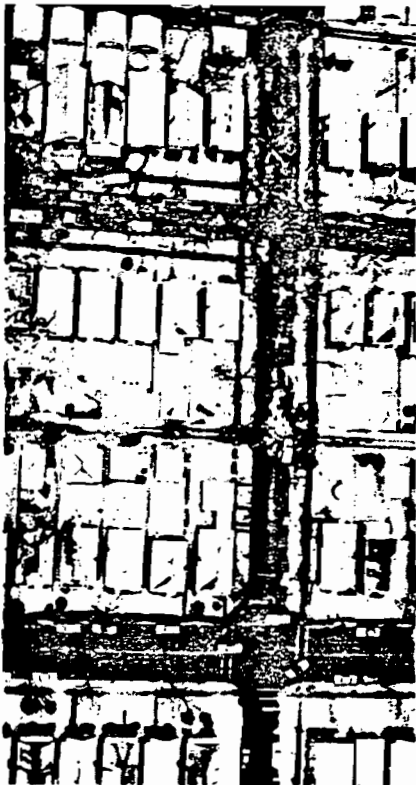
PHOTO "A"

- 17 SOUTHWEST CORNER OF HOUSE DAMAGED.
  - 18 SECTION OF RIGHT WING LEADING EDGE FOUND BETWEEN HOUSES.
  - 19 SECTION OF LEFT HORIZONTAL STABILIZER.
  - 20 SECTION OF FLAP TRACK INCLUDING JACK SCREW.

- 21 SECTION OF FLAP TRACK FAIRING.

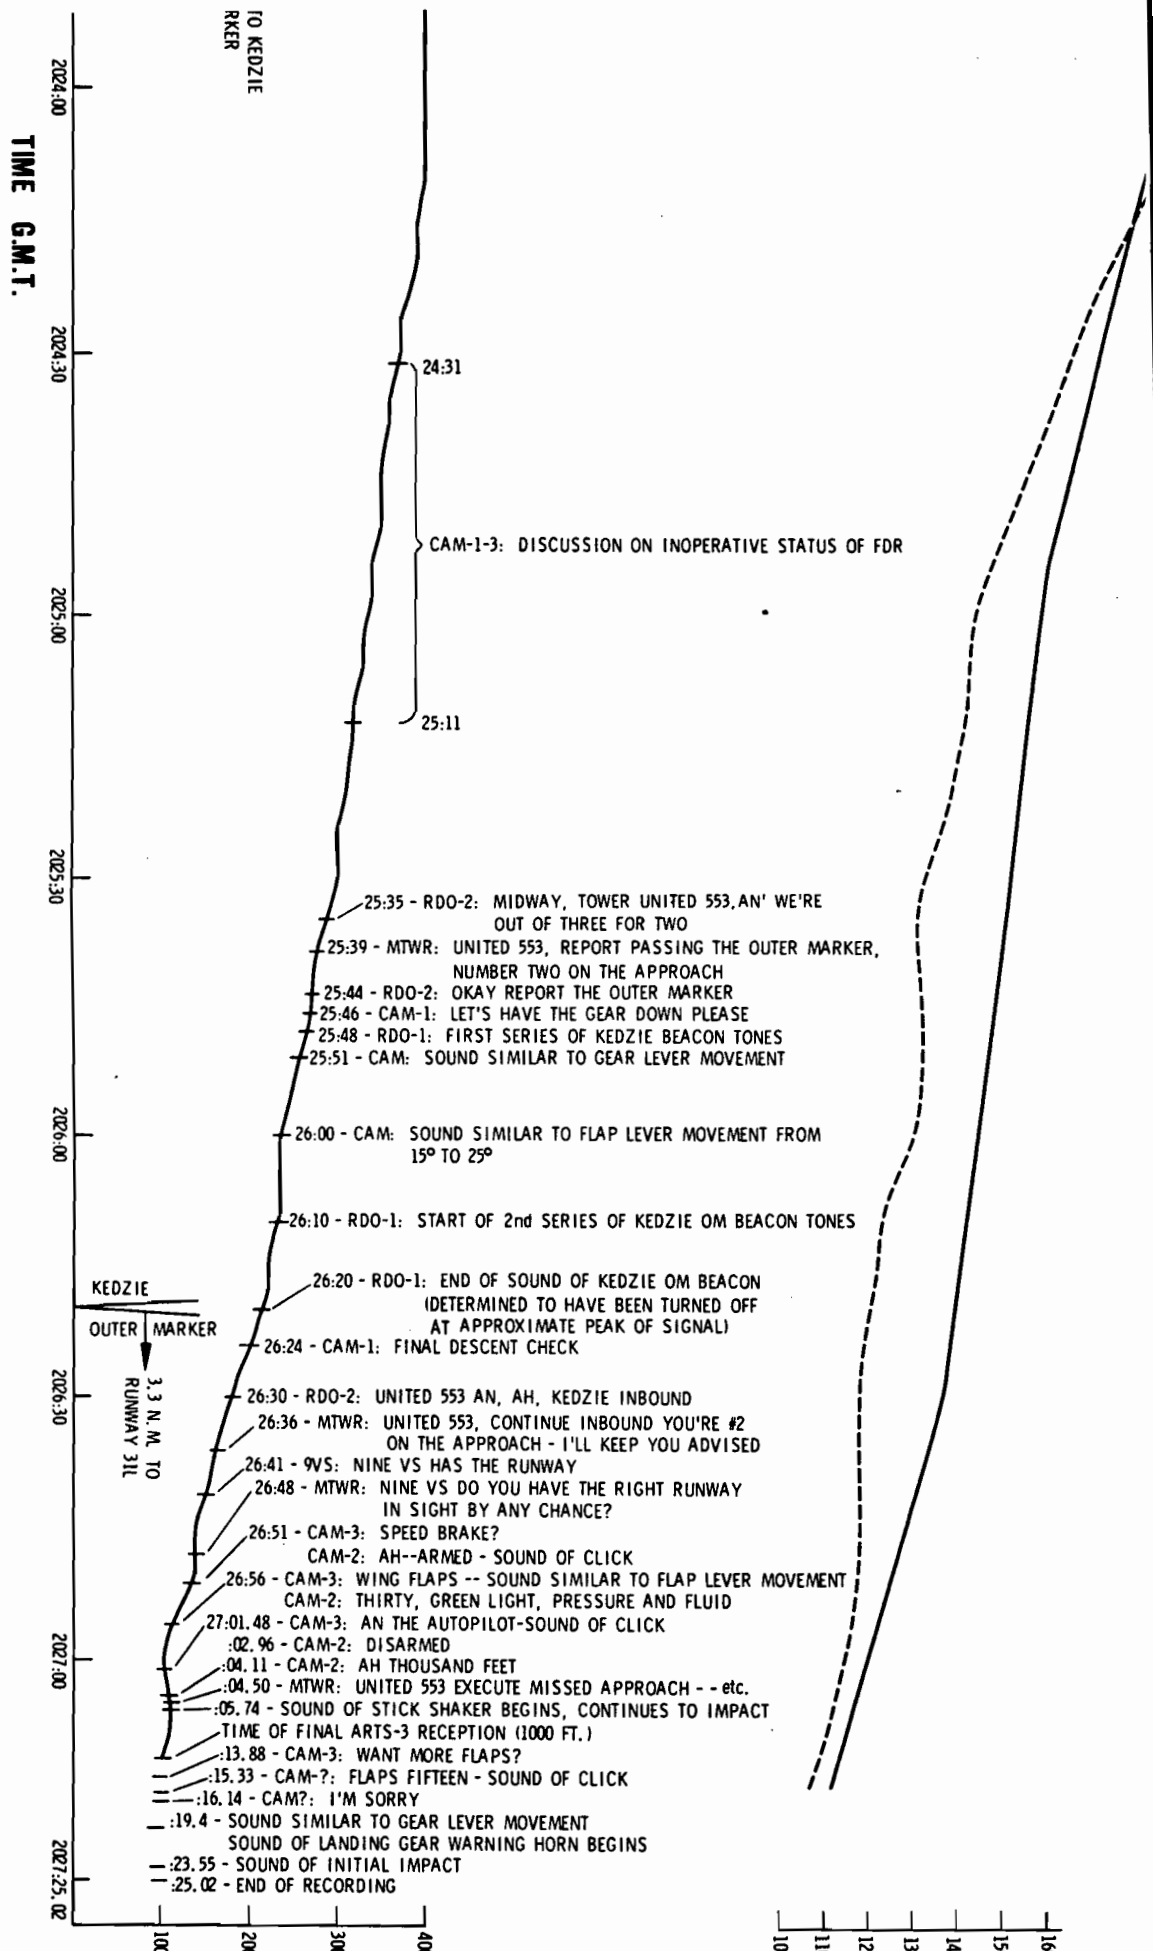
APPROACH PROFILE DERIVED FROM ARTS III AND CVR  
UNITED AIRLINES, INC. B-737, N9031U, FLIGHT 553  
NEAR MIDWAY INTERNATIONAL AIRPORT, CHICAGO, ILLINOIS  
December 8, 1972

The cumulative effect of the crew's apparent failure to ascertain their position on the localizer course was that the flight crossed the Kedzie OM at about 2,200 feet m.s.l., 700 feet above the published minimum crossing altitude. The Kedzie beacon signal may have been the crew's first positive indication of their inbound position. At that time, the aircraft's distance from Runway 31L was 3.3 nmi which was equivalent to 1 minute 39 seconds flying time at an average ground speed of 120 knots. When he recognized the situation that was developing, the captain increased the rate of descent to approximately 1,550 ft/min and immediately called for the final descent check. The company's nonprecision approach profile indicated that this checklist was to be completed before crossing the OM. Testimony by company flight management personnel at the public hearing indicated that this procedure was not mandatory in a nonprecision approach and that it depended primarily on the distance between the final approach fix (OM) and the runway. Considering the short distance between Kedzie and Runway 31L, the captain's delay in calling for the final descent check does not appear to be a preplanned course of action on his part. The resulting increase in the cockpit workload and disruption of crew coordination during the most critical phase of the approach turned out to be key elements in the development of the accident sequence.

4 seconds of reaching level-off altitude. The 1,500 ft/min descent from the outer marker to the MDA was in excess of that recommended in the company's operations manual.

The indicated airspeeds derived from the ARTS-III data showed a gradual deceleration during this descent, with level-off being initiated approximately at 120 knots. The theoretical performance of the B-737 conflicts somewhat with this evidence. The CVR sound spectrogram study showed that the power remained at 58 percent to 59 percent  $N_1$  throughout the descent. With the thrust produced under the existing conditions, a 1,550 ft/min descent can be achieved in a high-drag configuration, but the stabilized airspeed will be in excess of 130 knots. The performance study indicated that had  $30^\circ$  flaps been selected at 1426:00 and had the spoilers been extended to the flight detent position upon establishing the 1,550 ft/min descent, level-off would have been initiated approximately at 133 knots. Any configuration producing less drag would have resulted in a higher level-off airspeed, which would have been less compatible with the subsequent events. The aircraft's performance corresponding to this thrust and drag configuration was validated by the B-737 simulator tests. Therefore, the Safety Board concludes that level-off airspeed was closer to the theoretical value and that the final descent was accomplished in a  $30^\circ$  flap, landing-gear-down configuration with the spoilers extended to the flight detent position.
